Fence entirely made of iron with reinforced structure treated with Ferrus, a protective process that guarantees high resistance to corrosion.

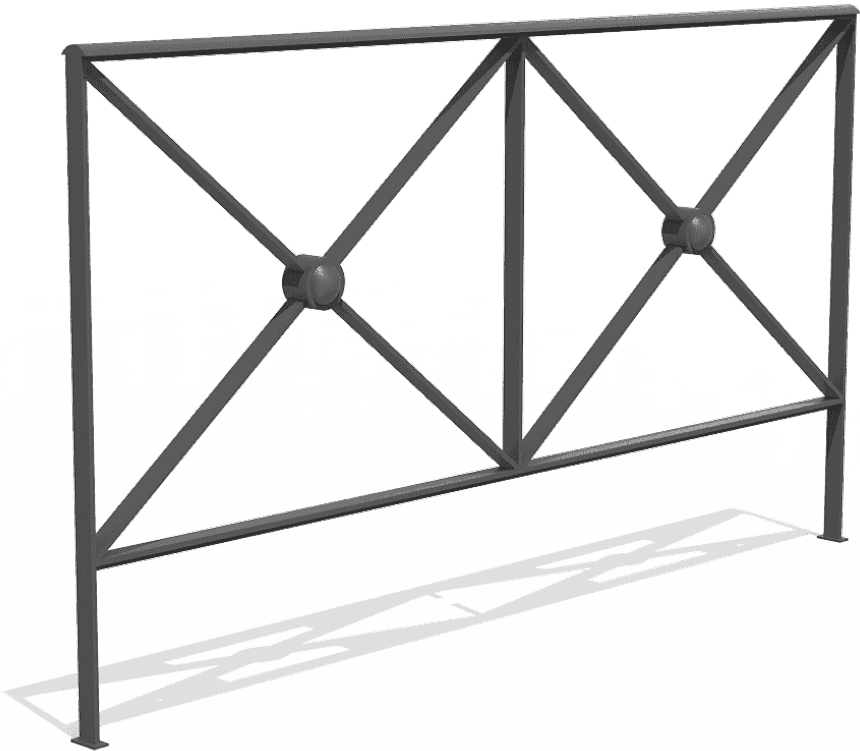
Ref.	A	H	H1
VVP002	2000	1110	830
VVP001	2400	1020	740

The Ferrus treatment consists of three layers applied after shot cleaning all impurities: an electrolytic bath, an epoxy coating and a forge black polyester paint coating.

Recommended anchoring: concrete foundation.
