Fence made of steel treated with Ferrus, a protective process that guarantees high resistance to corrosion.

VVBA84M/1 - VVBA164M/1

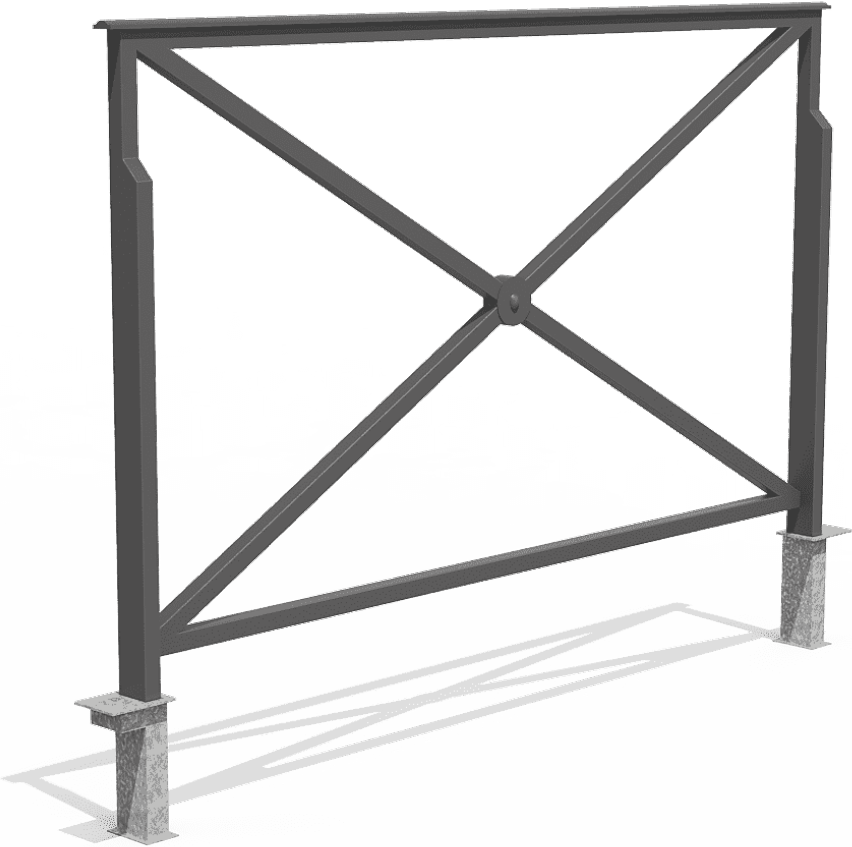
The Ferrus treatment consists of three layers applied after shot cleaning all impurities: an electrolytic bath, an epoxy coating and a grey RAL 7016 polyester paint coating.

Ref.	A	H	H1
VVBA84	840	1130	200
VVBA164	1640	1130	200

Recommended anchoring: concrete foundation.
